YOUR Inspection Report

62 Mordecai Lincoln Road - The Mordecai Home
Scituate, MA 02066

BEACON
STREET
HOME
INSPECTION

RE: Report No. 2043
62 Mordecai Lincoln Road - The Mordecai Home
Scituate, MA
02066

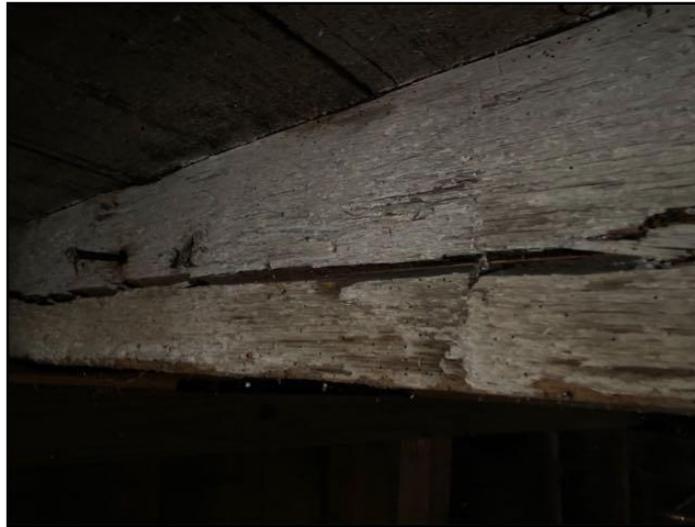
There are numerous older, hand-hewn beams and joists in the cellar hole that have horizontal cracks in them. Many of these older framing members have been sistered with new, dimensional lumber. These configurations should be further evaluated by a qualified contractor when the secondary wood post and beam in the cellar hole is addressed.

Example of older, cracked beam

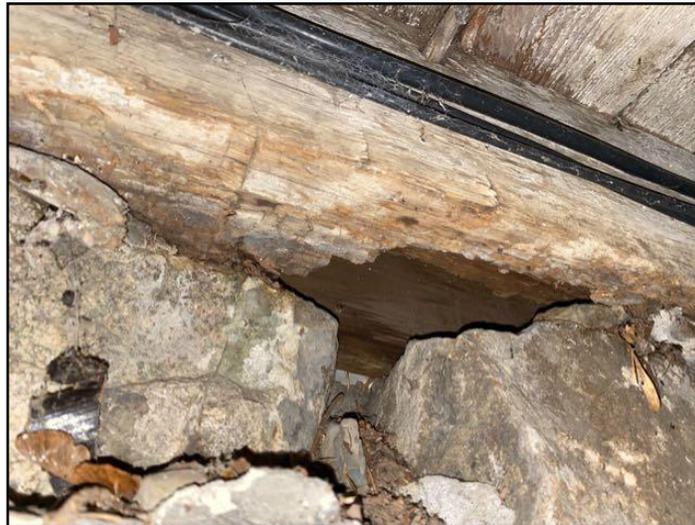
There is a section of visible decay and damage to the front sill near the left corner. The exact length or extent of the damage could not be clearly articulated but visual evidence would suggest that its at least 6-10 feet. This needs to be further evaluated by a qualified contractor. Note: the overwhelming majority of the building's sills and framing were not visible nor accessible due to poor or no clearance in the crawl spaces. There may be other such examples present. Further research is recommended. Sill repair can be a costly endeavor.

Decay in front sill

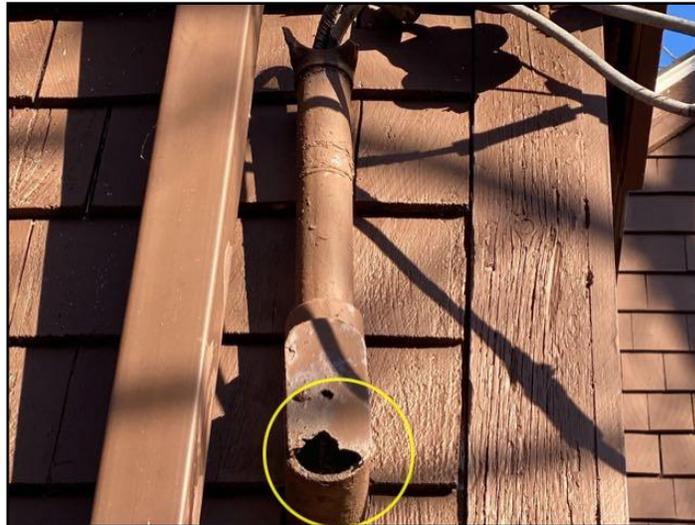
The plate cover at the incoming electrical service (front, left corner of home) has rusted through and is no longer weather tight. This is allowing water to enter the feature. This needs to be properly repaired.

Not weather tight

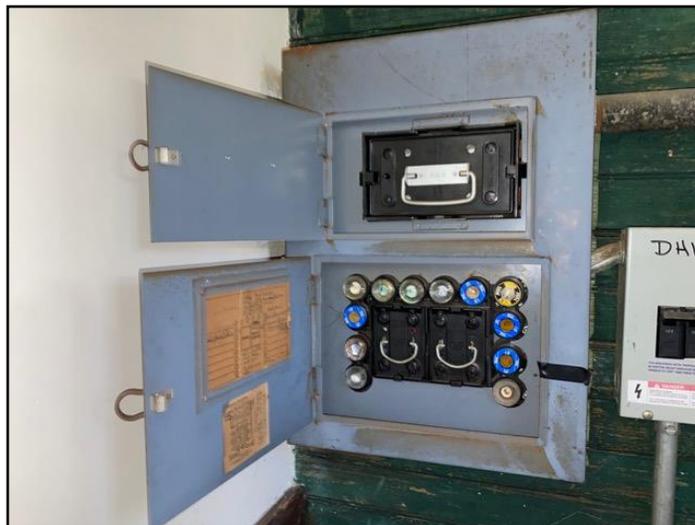
The electrical system, from its fused main panel, to its ungrounded distribution wiring, and its two-prong, ungrounded outlets is obsolete by today's electrical and safety standards. This fused panel has most likely be in use here since at least the 1960s, perhaps longer. Electrical components have anticipated life spans. This panel is beyond its lifespan. Recommend consulting with a licensed electrician to discuss a the scope and cost of upgrading the building's electrical system.

Obsolete electrical system

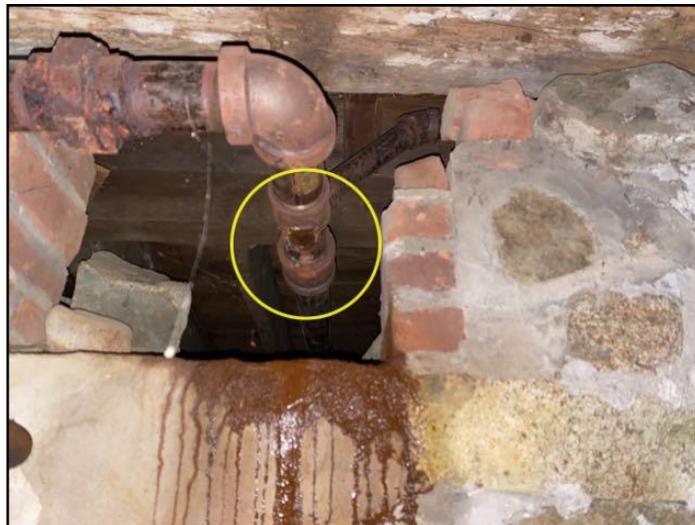
Active leak in heating pip

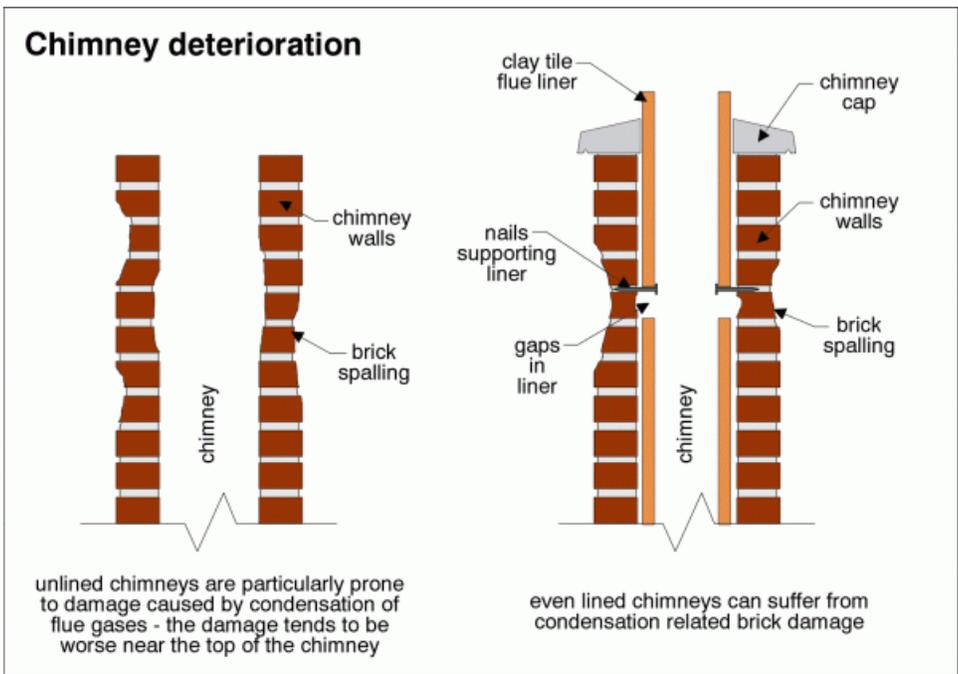
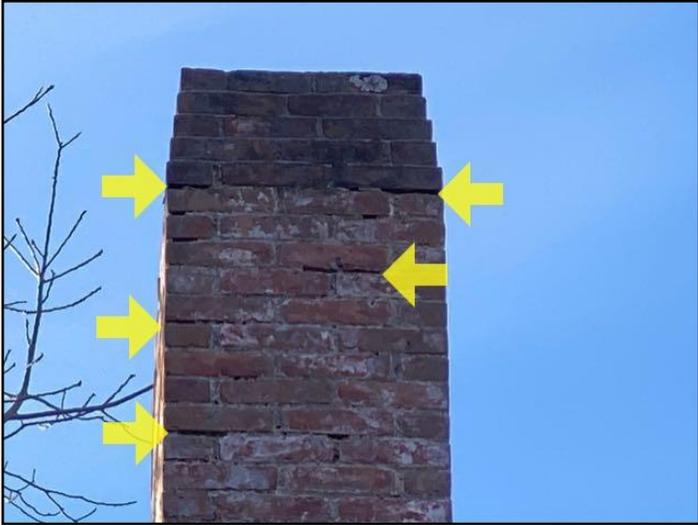
Failing mortar joints on rear chimney

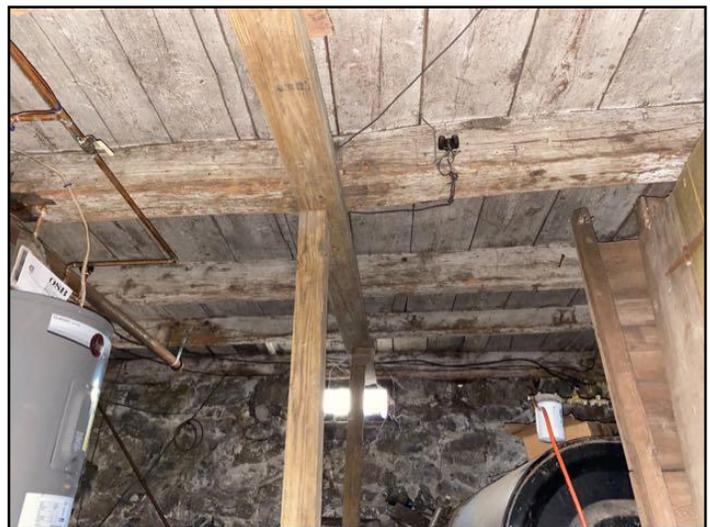
Too little insulation

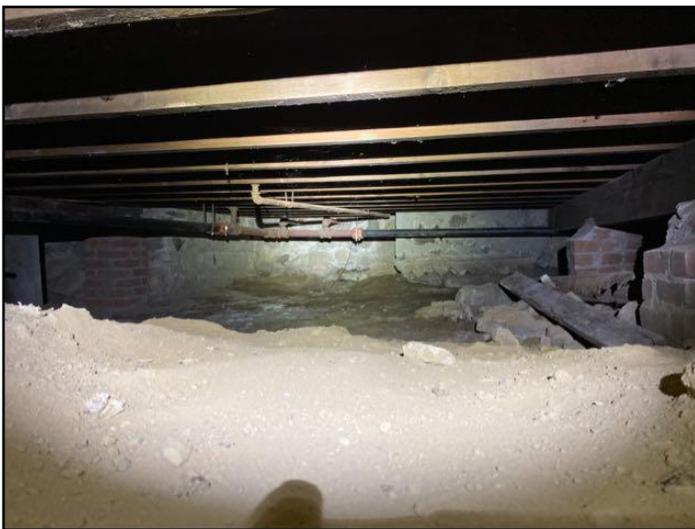
No vapor barrier

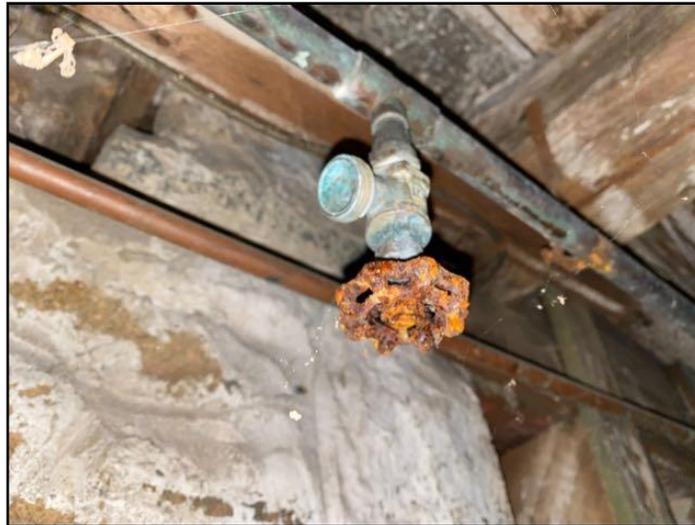
Repair/replace older turn valves

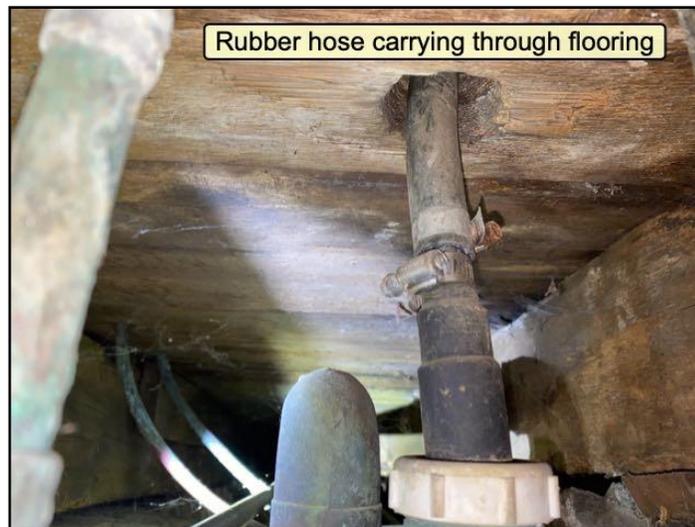
Hose carries through floor

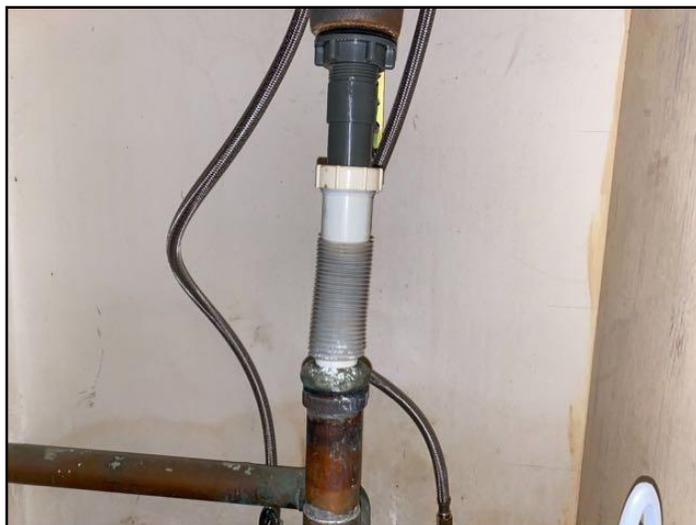
Flexline drain piping not recommended

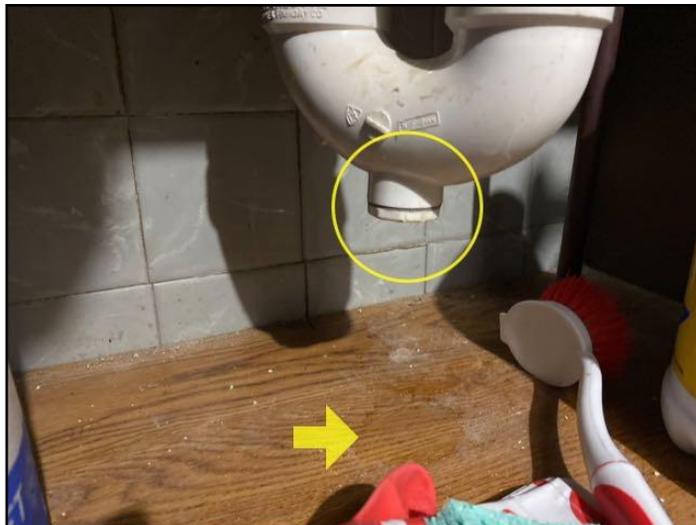
Leak in drain line

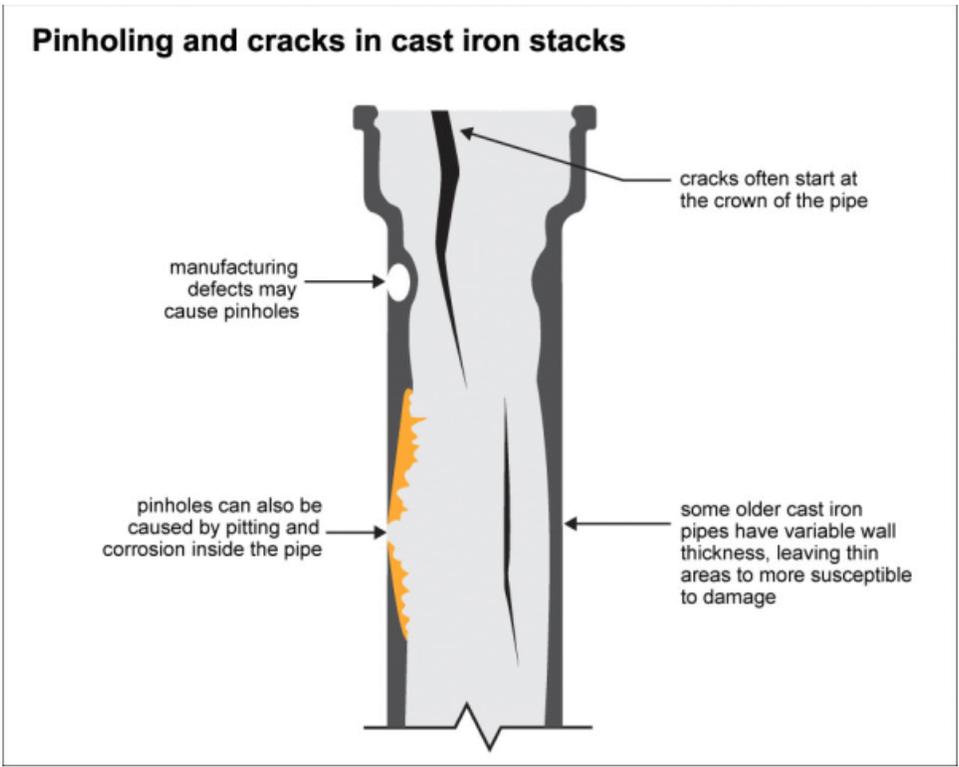
Aging cast iron drain lines

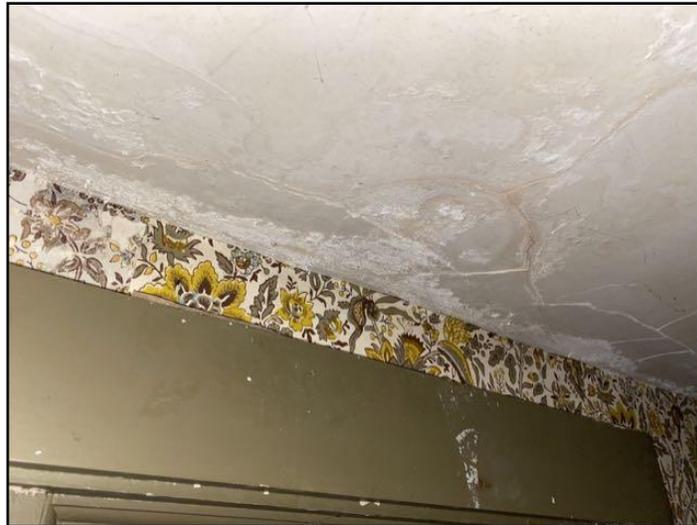
Old water damage to ceiling and wall

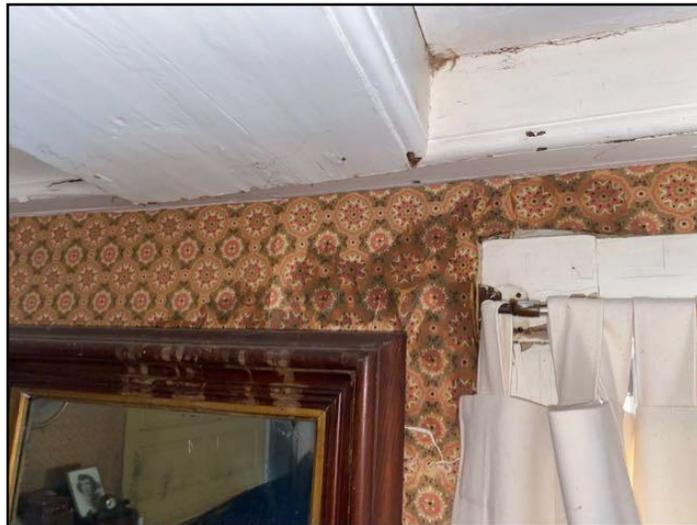
Water damage
